AGARD Corrosion Handbook Volume 1 Aircraft Corrosion: Causes and Case Histories

AGARDograph No.278
AGARD CORROSION HANDBOOK
VOLUME 1

AIRCRAFT CORROSION: CAUSES AND CASE HISTORIES

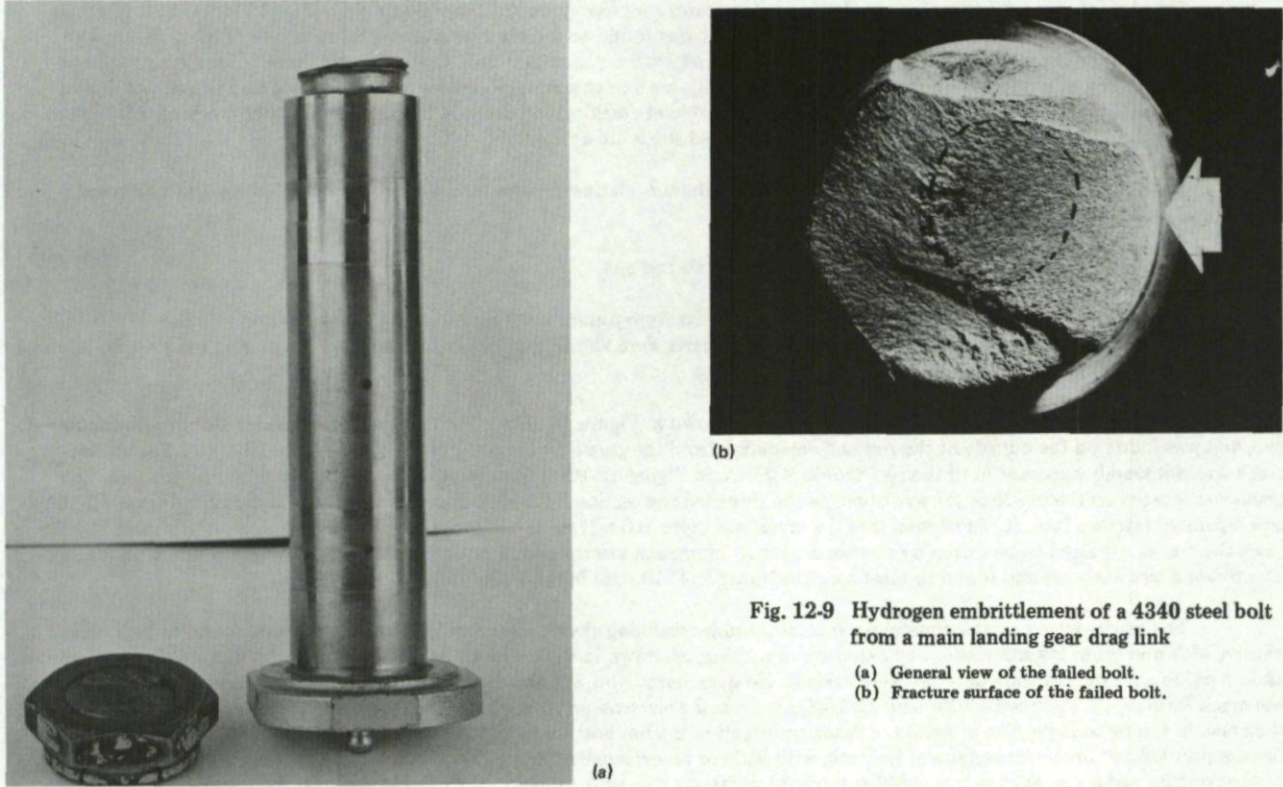
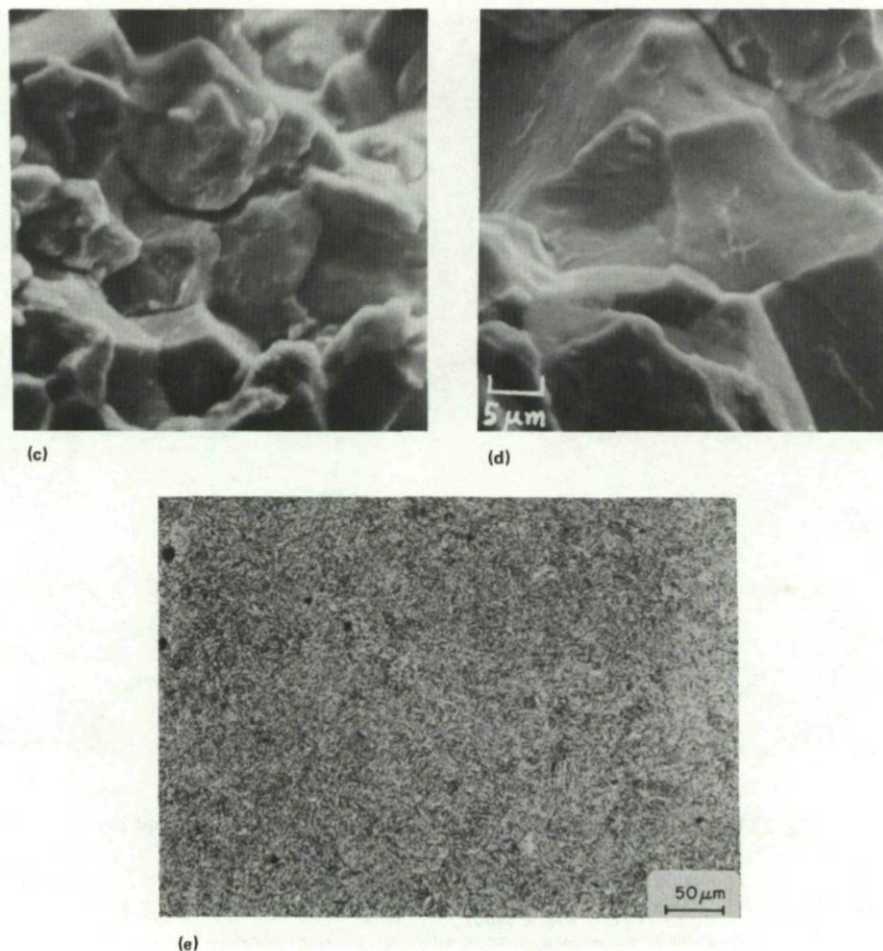
Fig. 12-9 Hydrogen embrittlement of a 4340 steel bolt from a main landing gear drag link

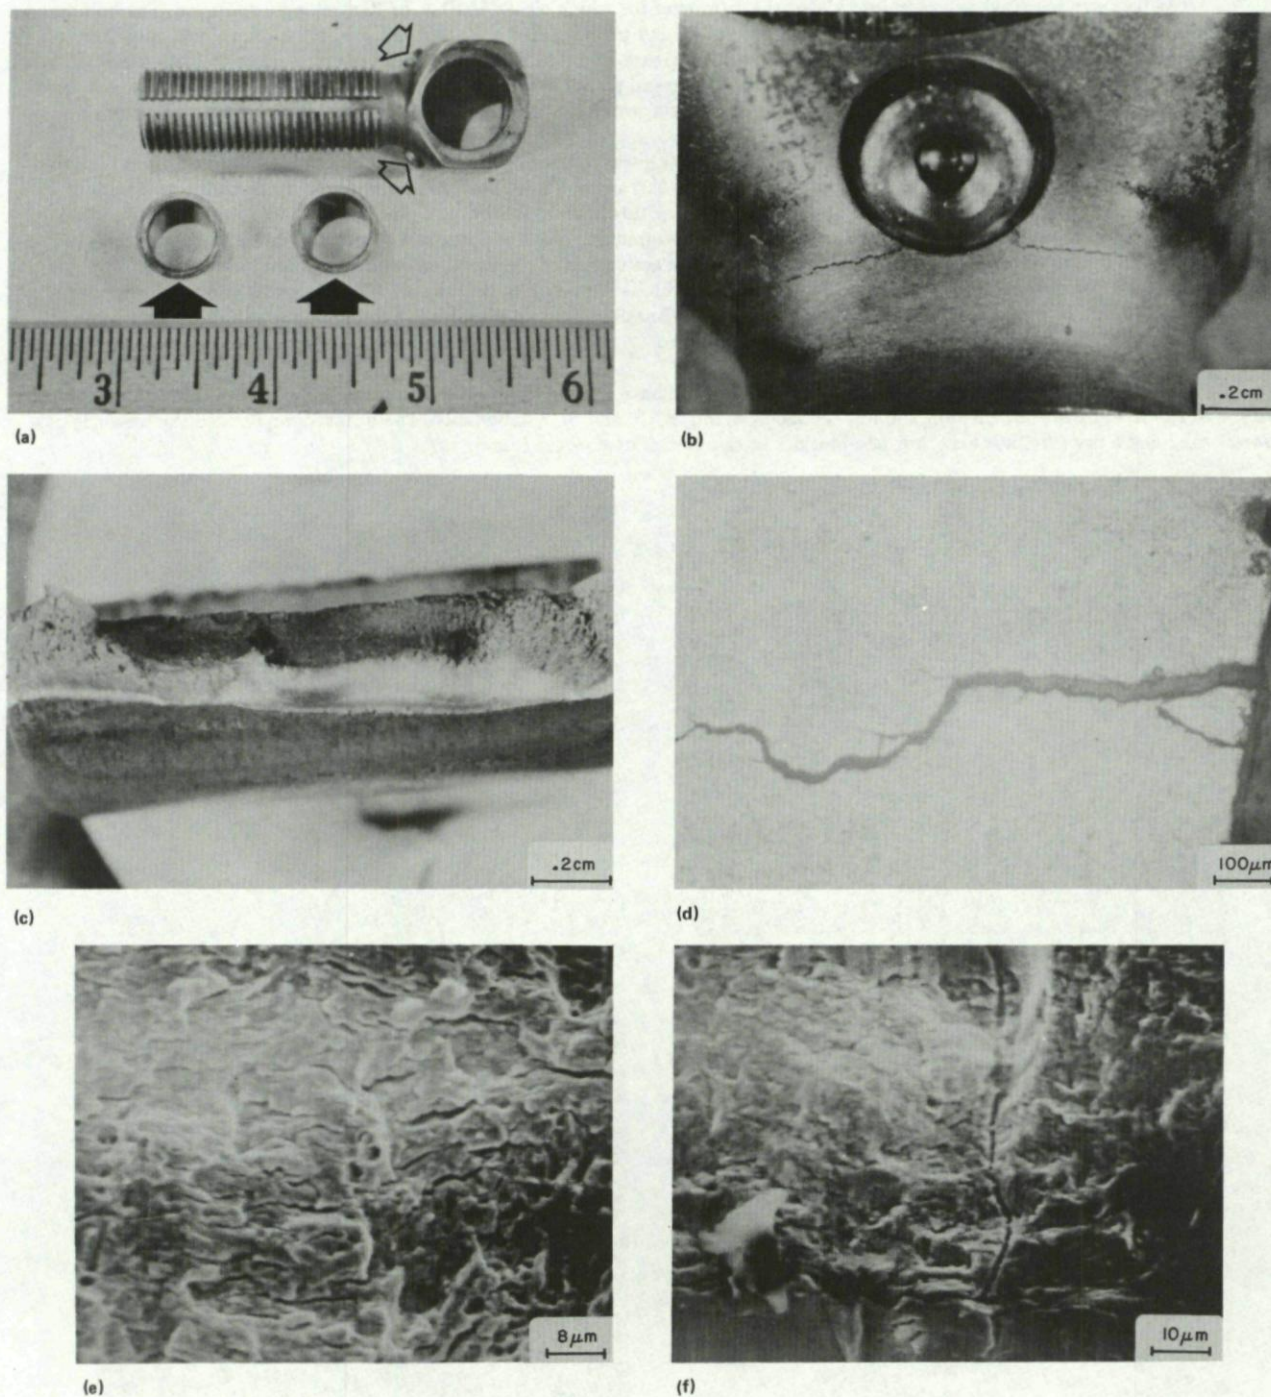
Fig. 12-10 Failure of a 4340 steel tie rod end

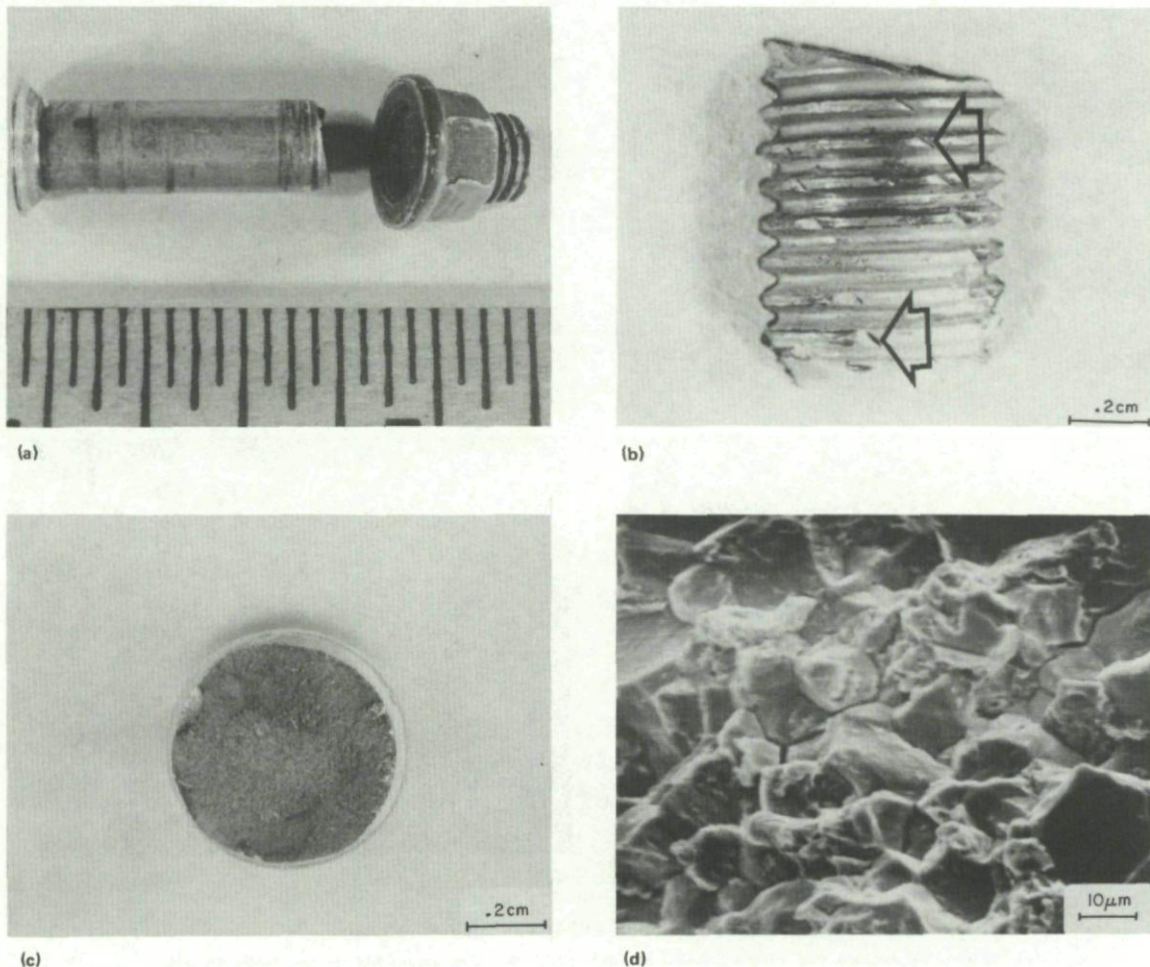
Fig. 12-11 Failure of a low alloy steel bolt

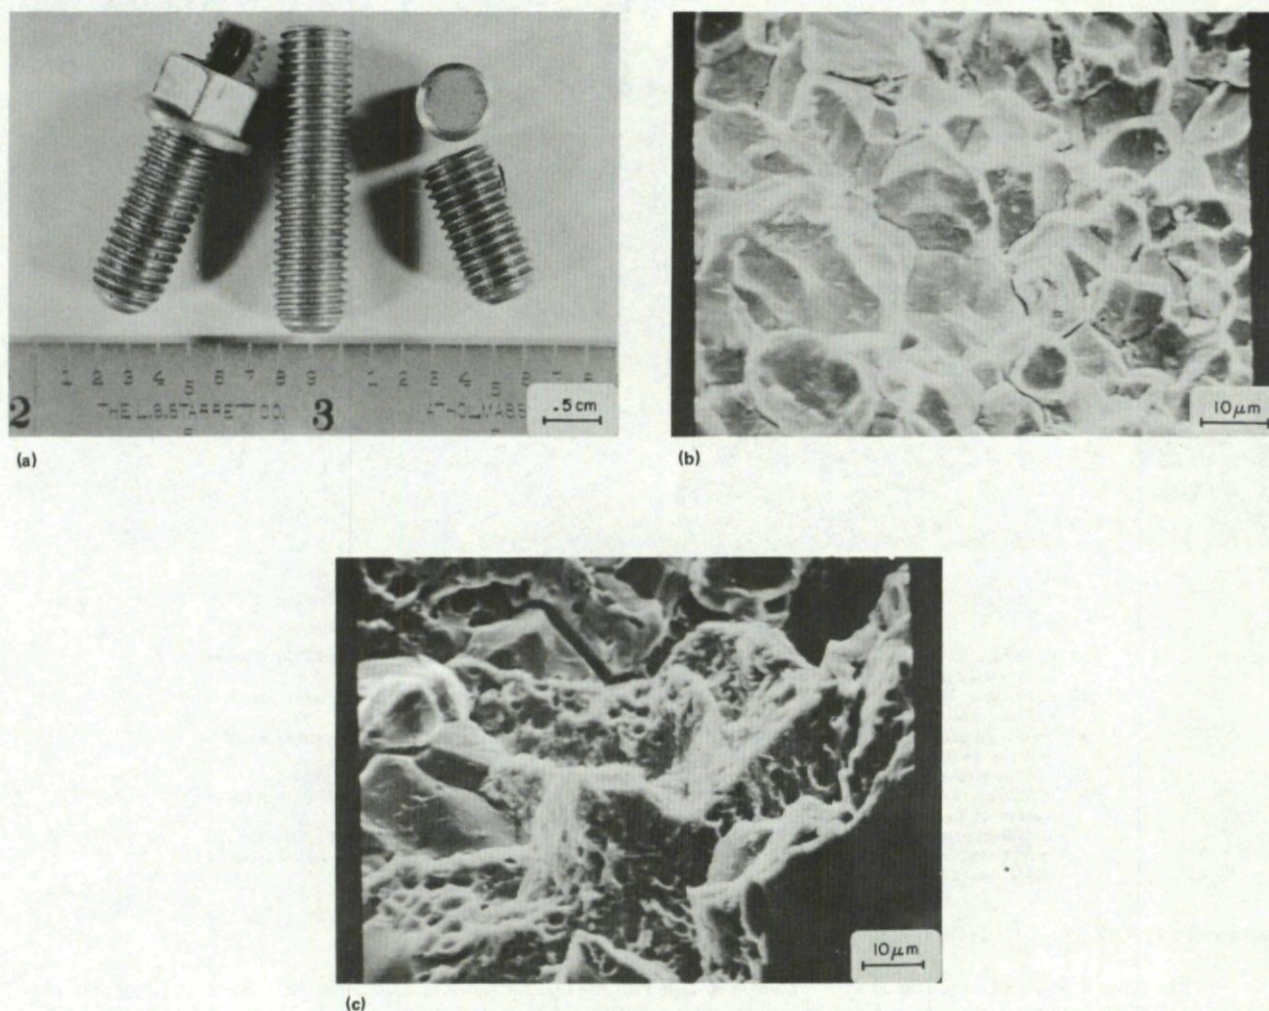
Fig. 12-12 Hydrogen induced failure of some 4037 steel setscrews

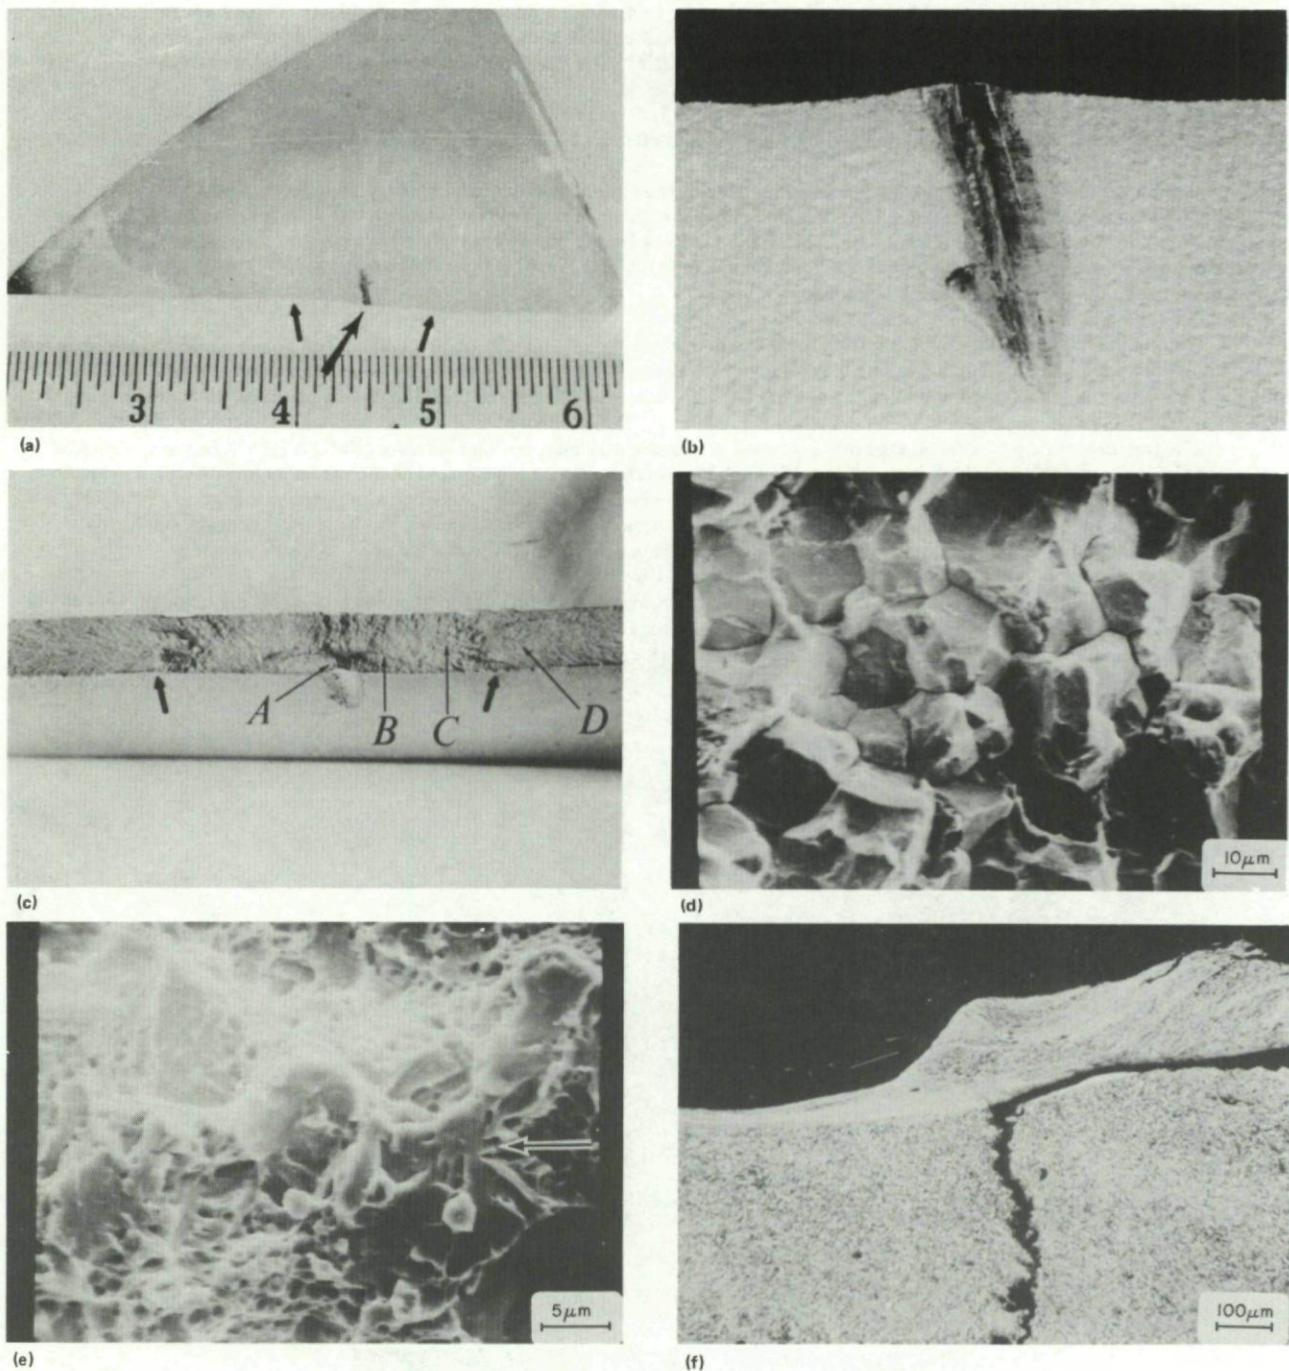
Fig. 12-13 Failure of a 4340 steel landing gear cylinder

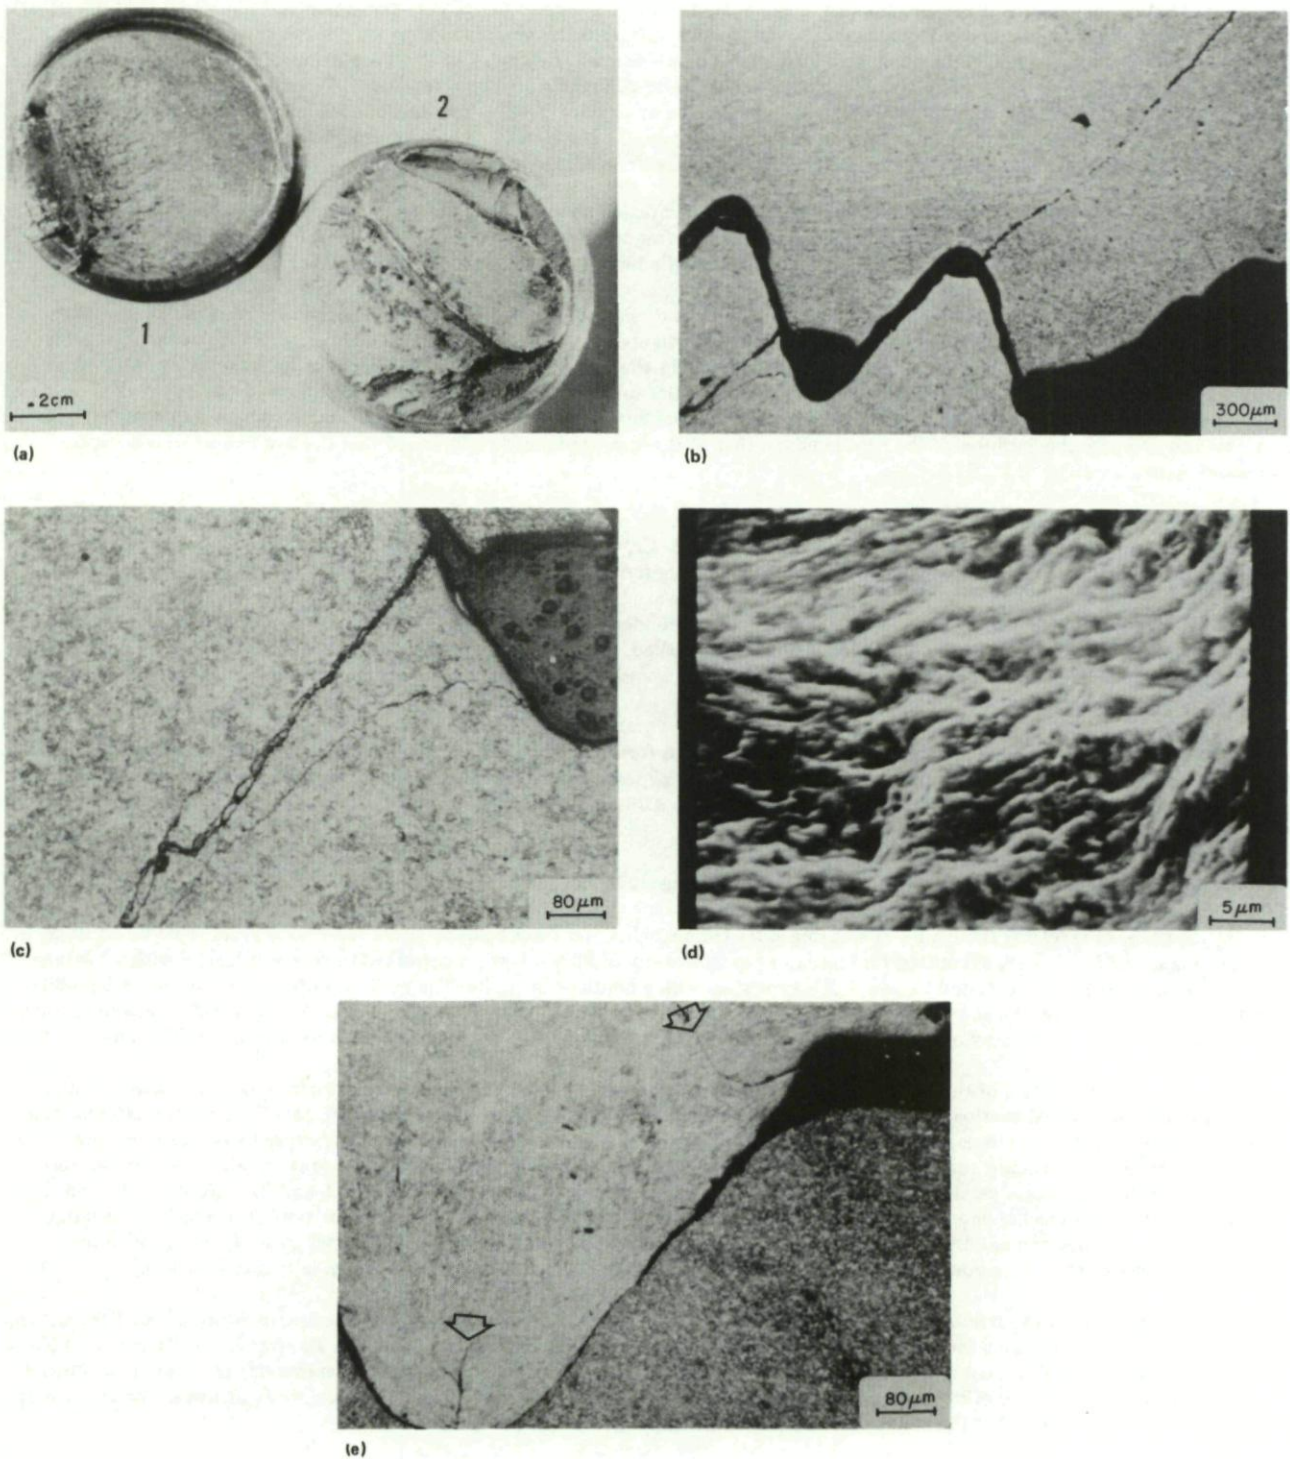
Fig. 12-14 Failure of two low alloy steel bolts

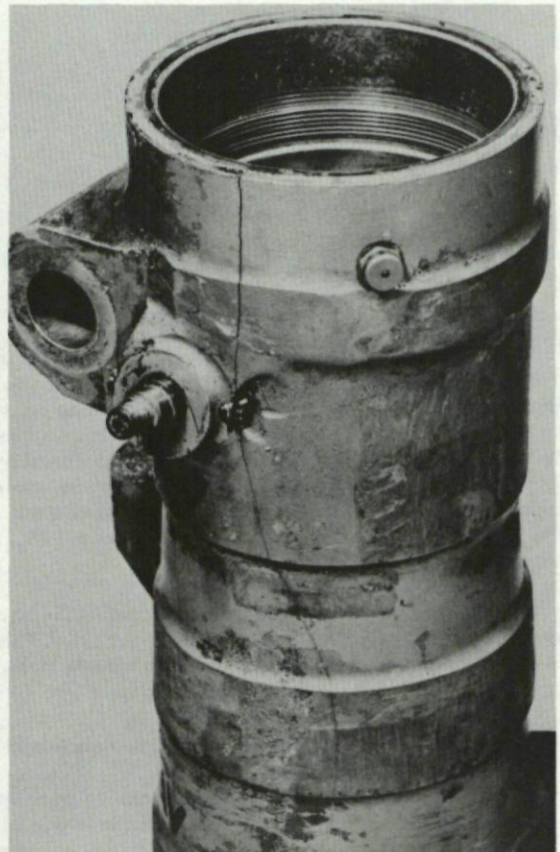
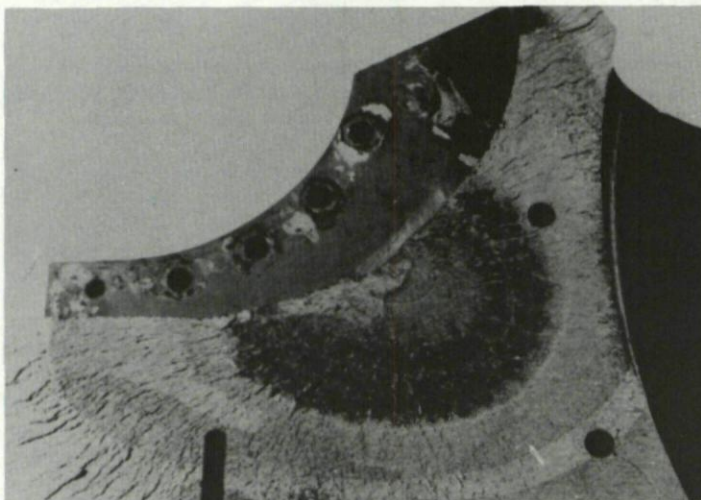
Fig. 13-1 Examples of stress corrosion cracking in aluminium alloy components

Stress corrosion is a particularly insidious form of corrosion since it will often occur with little or no visual evidence of surface corrosion such as discolouration or the build up of noticeable corrosion products. This is illustrated in Figure 13-1(a), which shows stress corrosion cracking in the bosses of a forged aluminium alloy component. The cracks can travel over long distances with time, as indicated in Figure 13-1(b), and as they propagate they lower the residual strength of the affected part. Figure 13-1(b) shows stress corrosion cracking which initiated at corrosion pits in the flat lower surface of an undercarriage leg, the corrosion pits having served as local stress raisers. Stress corrosion cracks may propagate deeply into thick section parts, as indicated in Figure 13-1(c), while the visible surface crack length may often be quite small. The banded appearance of the fracture surface in Figure 13-1(c) is an indication that crack growth occurred in a slow, time dependent manner, and macroscopically the fracture surface may resemble

- (a) Cracks in the bosses of a forging.
 (b) SCC in an undercarriage leg.
 (c) Stress corrosion fracture surface in an aluminium forging.

fatigue. The part shown in Figure 13-1(c) was a high strength aluminium-zinc alloy forging and the stress corrosion cracking was attributed to poor forging and heat treatment practice which produced a microstructure susceptible to SCC. The part was also thought to have contained high residual stresses as a result of poor machining practices, and the corrosive environment experienced in service was the final parameter leading to SCC.

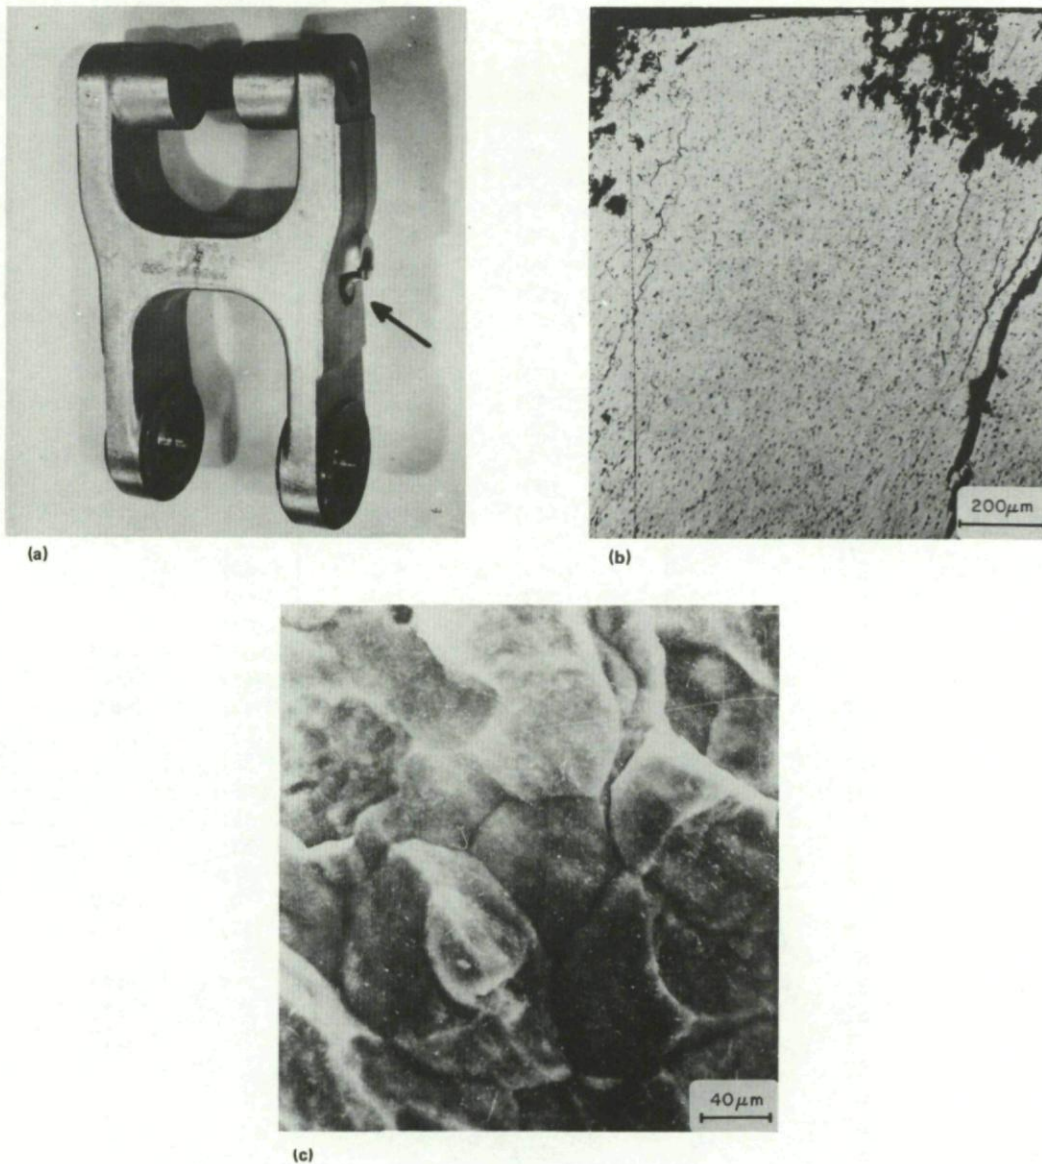
Fig. 13-7 Stress corrosion cracking occurring from corrosion pits and intergranular corrosion cracking in the parting plane of a 7079-T6 H-link.

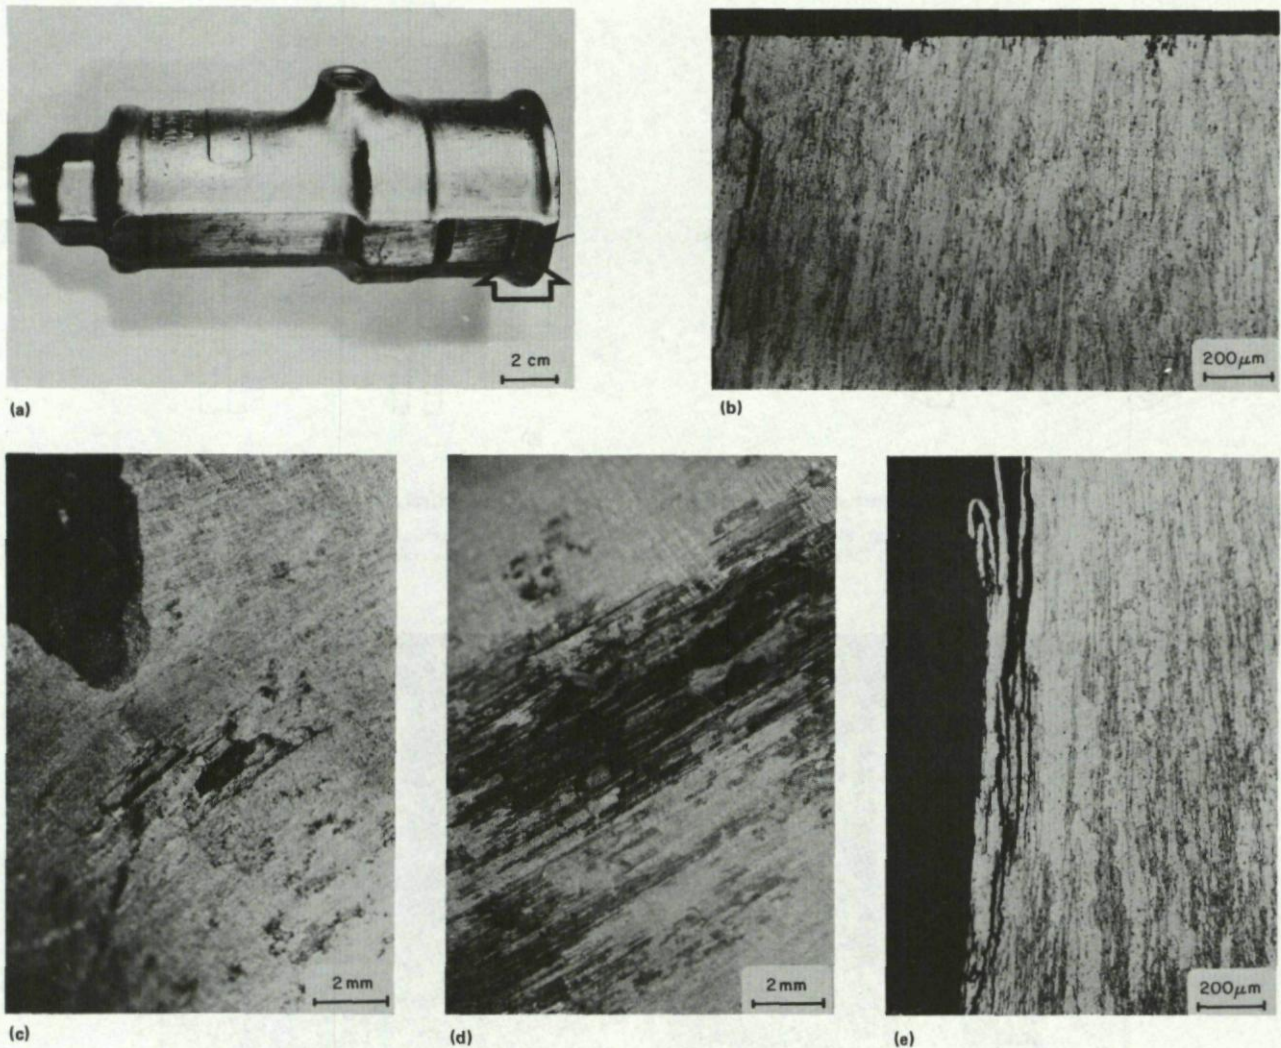
Fig. 13-26 Stress corrosion cracking in a 7079-T6 main landing gear locking cylinder, case history 13-1.

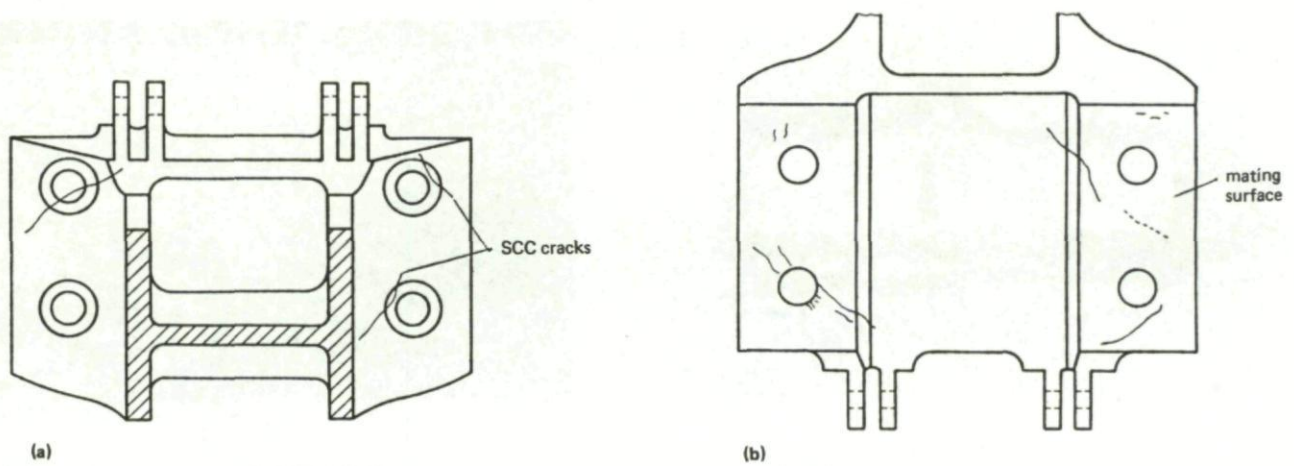
Several cracks were found in the front and rear spars of a fighter aircraft during a routine inspection using eddy current methods. The locations of the cracks in the parts are shown schematically in Figures 13-27(a) and 13-27(b), which show the front and rear spars respectively. The spars were made from 7079 die forgings, and were artificially aged to the peak strength condition according to the specification QQ-A-367. All surfaces of the spars had been shot peened after machining, and had been treated with a chromate conversion coating and a single layer of zinc chromate primer.

The spars were removed from the aircraft to allow closer visual inspection and the cracks could be seen clearly to be up to several centimetres long as indicated in Figure 13-28(a). Many of the cracks were found to propagate from fastener holes as indicated in Figures 13-27 and 13-28. The front and rear spars were mounted in a jig, and loaded statically to cause failure so that the crack surfaces were revealed. A typical fracture surface observed in the front spar is shown in Figure 13-28(b), and this shows a dull fan-shaped region which appears to have initiated in the radius at the base of a bolt access hole as indicated by the arrow, and a lighter area which was produced by the static overload fracture. The dull area was typical of stress corrosion cracking showing evidence of corrosion and arrest lines indicating that cracking had occurred progressively over a period of time. Metallographic examinations showed that the material had a fine-grained recrystallized microstructure, and the cracks were found to run along grain boundaries, as is expected with stress corrosion cracking in this class of alloy.

It was concluded that the cracking was due to stress corrosion which had occurred because of the use of a stress corrosion prone alloy. While the spars had received corrosion protection treatments, damage to the surface coatings during the installation of bolts had exposed bare metal and stress corrosion had occurred as a result of the high humidity and high sustained tensile stresses arising from fastener installation. To overcome this problem the spars were machined from 7075-T73 forgings, which as discussed in Section 13-5 provide high resistance to stress corrosion cracking. The surface protection system used previously, including shot peening to develop compressive residual stresses, followed by chemical conversion coating and zinc chromate priming, was retained. An alternative solution involving the use of 7175-T736 was also considered in order to maintain high strength, equivalent to or higher than the original 7079-T6 values, together with improved stress corrosion resistance.

Fig. 13-27 Stress corrosion cracking in the 7079-T6 spars of a vertical fin, case history 13-2.

- (a) Sketch of the front spar showing the location of the cracks.
 (b) Sketch of the rear spar showing the location of the cracks.

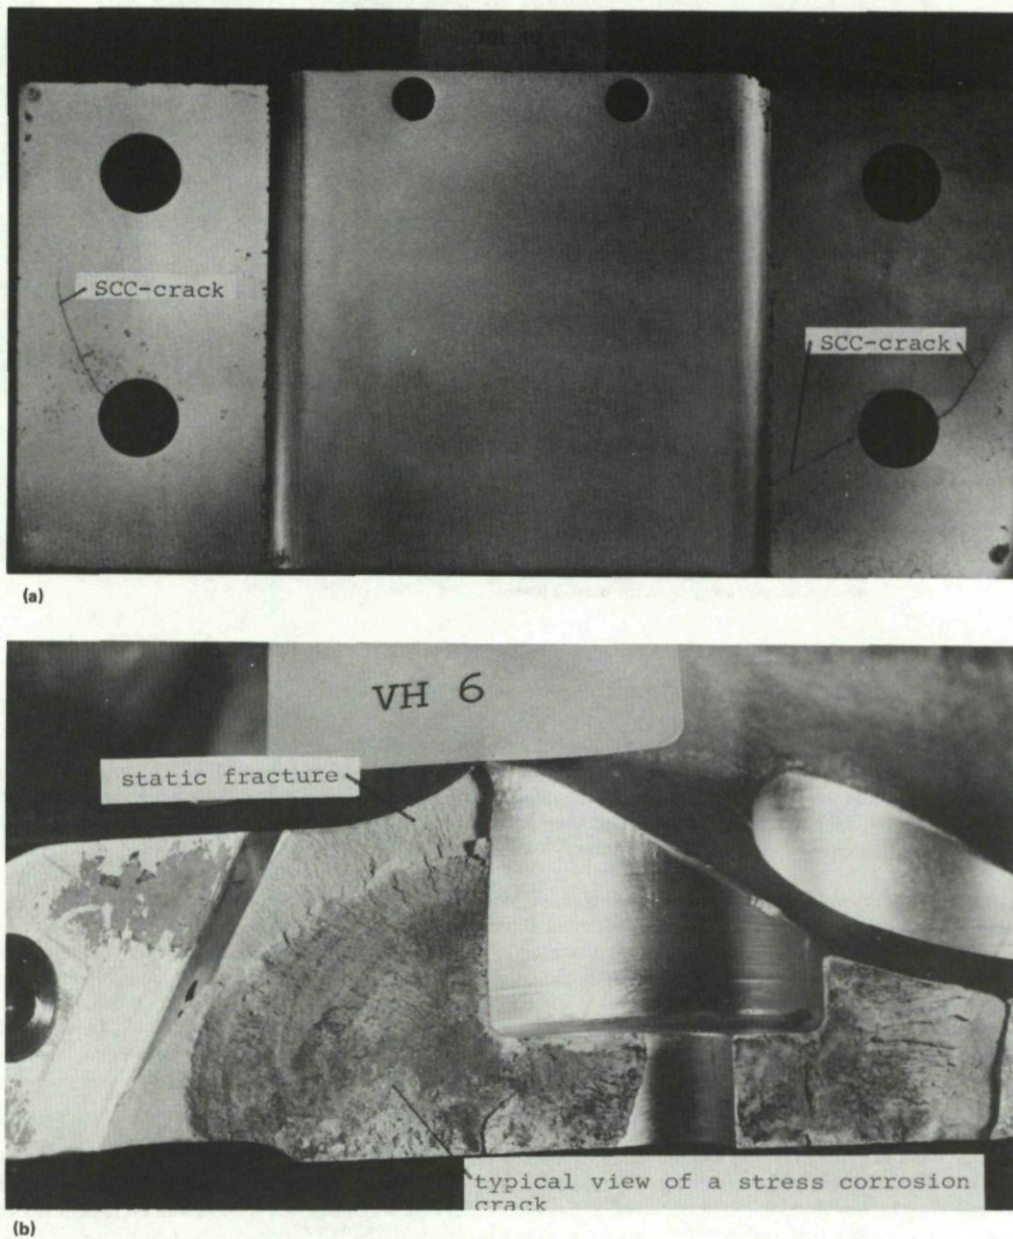
Fig. 13-28 Stress corrosion cracking in the 7079-T6 spars of a vertical fin, case history 13-2.

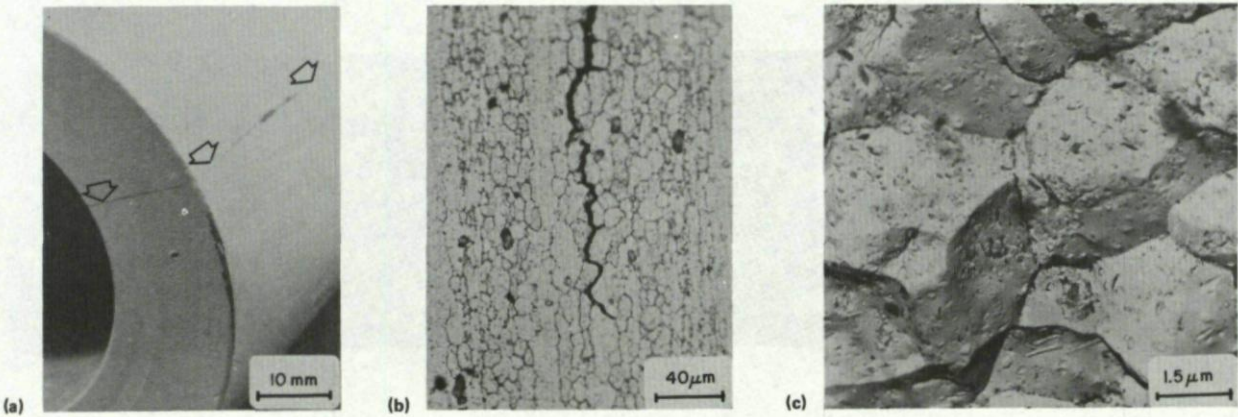
During a major repair of a fighter aircraft a crack was found in the pivot bearing housing at the top end of the vertical stabilizer beam. Figure 13-29(a) shows the crack as it was found by dye penetrant inspection. Figure 13-29(b) shows a metallographic cross section through the tip of the crack, and this shows that the crack follows grain boundaries aligned along the length of the bearing. Figure 13-29(c) shows a replica transmission electron micrograph of the fracture surface, which again reveals the intergranular nature of the fracture surface.

Fig. 13-29 Stress corrosion cracking in a 7079-T6 bearing housing, case history 13-3.

- (a) End of the bearing housing showing the location of the crack.
- (b) Metallographic section through the tip of the crack showing the intergranular nature of cracking.
- (c) Electron micrograph showing the intergranular fracture topography.

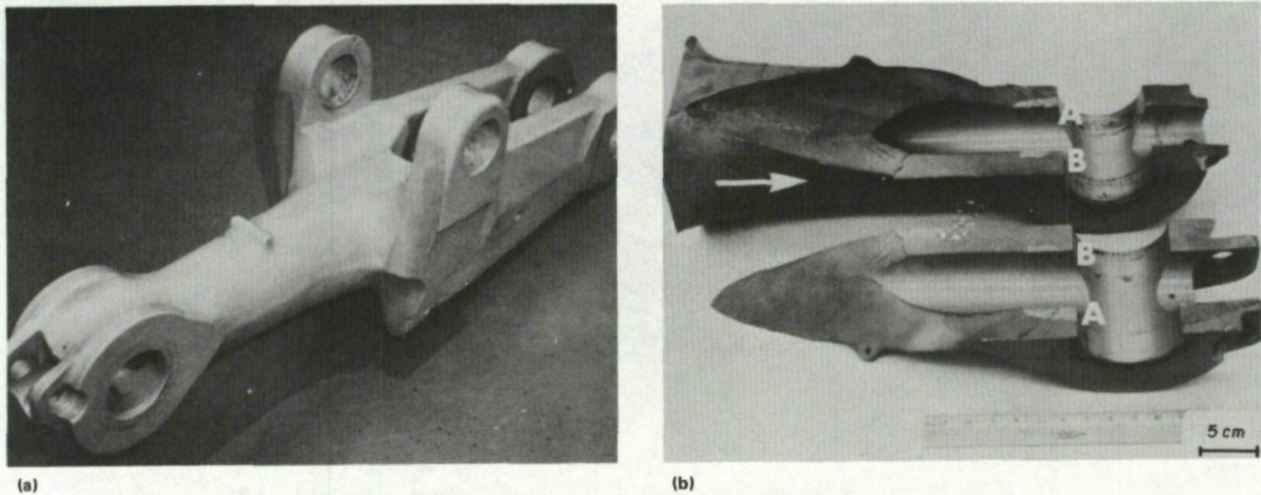
The main landing gear bogie of a large turboprop transport aircraft failed on touchdown, fortunately without causing a serious accident. The part was found to be made from a 7075-T6 forging of the type shown in Figure 13-30(a), and was found to have split along the forging parting plane as indicated in Figure 13-30(b). The tip of the white arrow in Figure 13-30(b) indicates the position of the crack tip in the parting plane, and therefore indicates the maximum extent of cracking in the parting plane. The longest crack was nearly 30 cm long at failure, but since the forging surface had been fully shot peened, the surface residual compressive stresses had prevented the growing cracks from breaking through to the surface and hence revealing themselves to surface inspection. Cracking initiated at the main axle bore, where the most susceptible end grain boundaries on the forging parting plane were exposed by the machining process. Cadmium plated steel bushings were mounted in the main axle bore by interference fit, and corrosion pits were found in the aluminium forging underneath the bushings. Thus even though cadmium plating was used, there appears to have been a sufficiently high galvanic potential in the presence of moisture to initiate pitting attack which led in turn to stress corrosion cracking. The stresses driving SCC in this part were due to the interference fit bushings and residual stress resulting from the post-forge heat treatment operations.

Fig. 13-30 Stress corrosion cracking in a 7075-T6 main landing gear bogie, case history 13-4.

- (a) New and unused bogie.
- (b) Failed bogie beam showing the crack initiation sites (A and B) underneath the shrunk-in steel bushings for the main axle bearings. The arrow tip indicates the maximum extent of the crack in the parting plane.

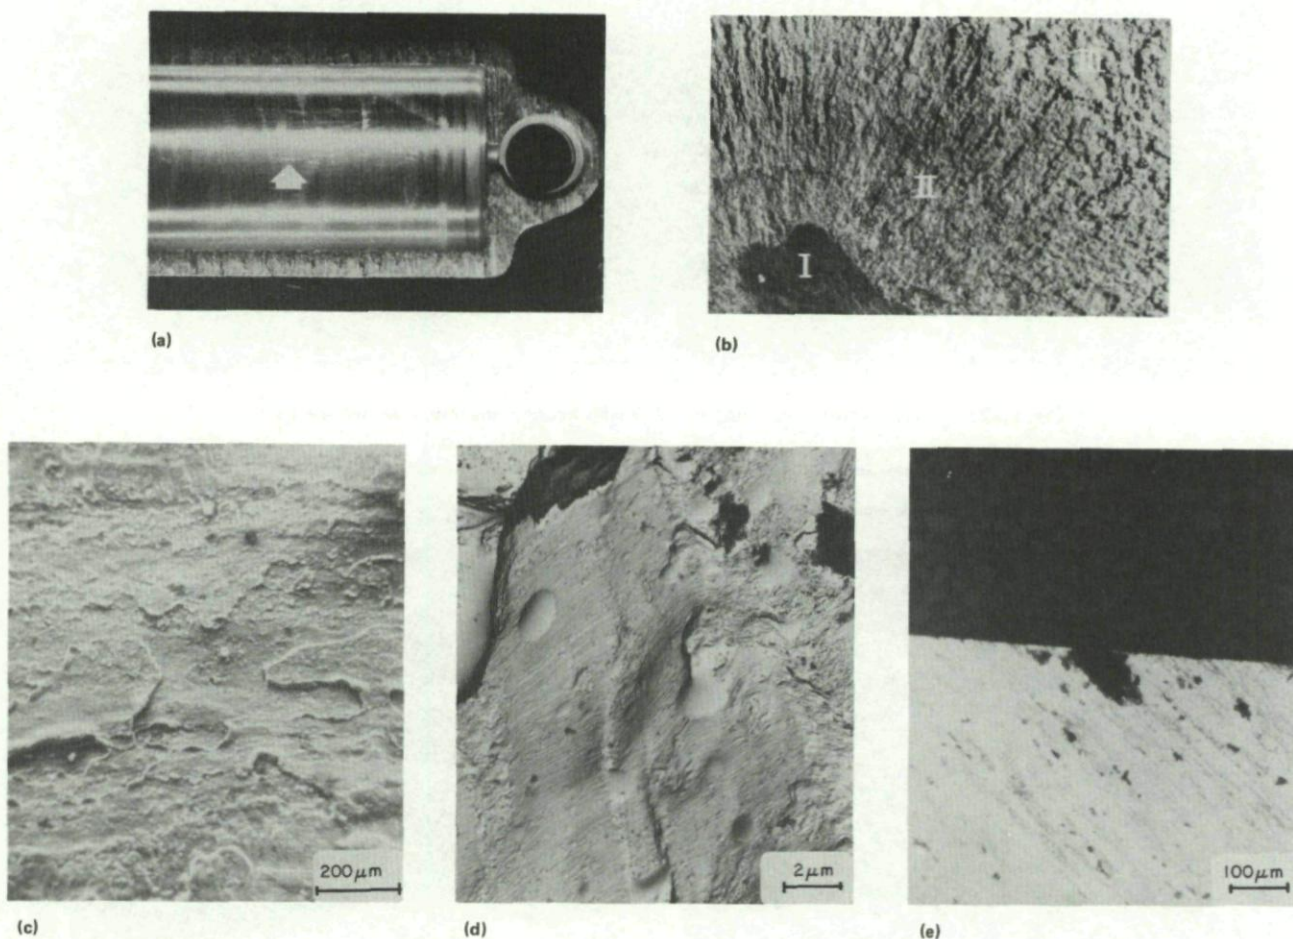
Fig. 13-31 Stress corrosion cracking of a 7075-T6 hydraulic cylinder, case history 13-5.

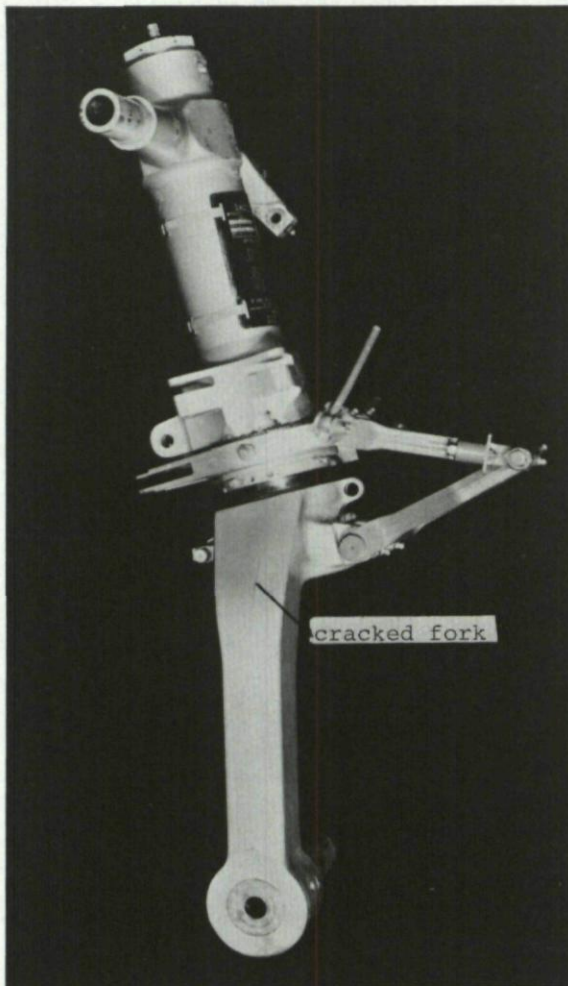
(a)

During a post-flight visual inspection of a fighter aircraft a long crack was found in the nose landing gear fork. The part is shown in Figure 13-32, and the crack which can be seen in this figure was found to lie in the parting plane of the aluminium alloy forging. The forging was made from 7075-T6 and its surfaces were treated with a single coat of wash primer plus two coats of acrylic paint.

Fig. 13-32 Stress corrosion cracking in a 7075-T6 nose landing gear fork, case history 13-6.

The crack was found to extend through the thickness of the fork, as indicated in Figures 13-32(b) and 13-32(c), and when the crack was opened up it was found to extend over about three quarters of the longitudinal cross section of the fork, as indicated in Figure 13-33. Figure 13-34(a) shows the fracture surface and reveals a dull fibrous fracture typical of stress corrosion cracking, where the crack appears to have started in the upper bore for the nose-landing gear leg attachment and the adjacent bore hole, which was introduced as a weight saving measure. However while the bores may have been effective in respect to weight savings, they provided natural traps for moisture. Figure 13-34(a) also reveals a narrow ribbon of material along both external surfaces which appear to have a lighter appearance than the area affected by SCC, and this suggests that the stress corrosion crack may have propagated over a substantial distance through the NLG-fork before breaking through to the external surfaces. Thus the crack may have been hidden for a substantial period of time prior to visual detection. Figure 13-34(b) shows a metallographic section through the crack tip and demonstrates quite clearly that the crack had propagated along grain boundaries, as expected for SCC in this type of alloy. The intergranular fracture mode was confirmed by scanning electron microscopy.

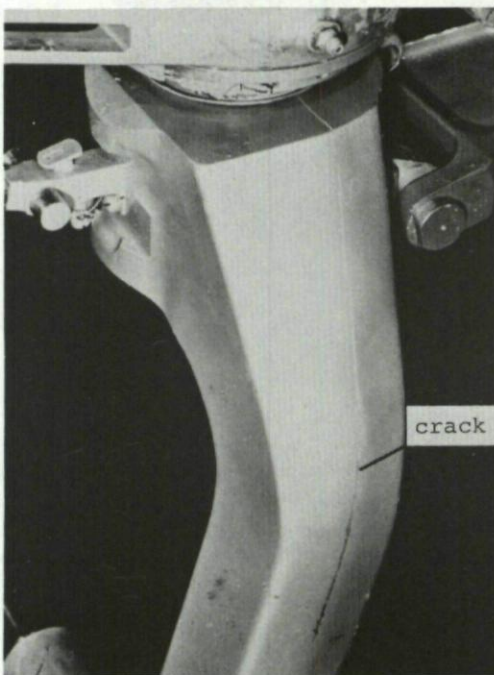
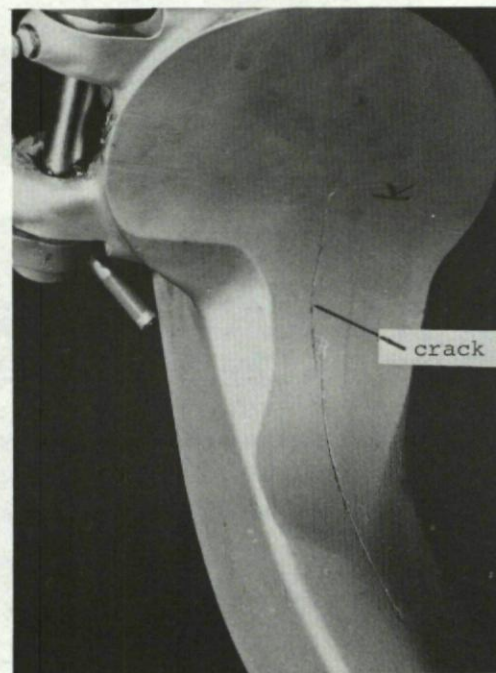
- (a) Complete landing gear assembly.
- (b) Close-up of the fork outer surface showing the crack.
- (c) Close-up of the fork inner surface showing the crack.

It was concluded that cracking was due to stress corrosion and this was a consequence of the use of a stress corrosion susceptible alloy, exposure of end grain boundaries at the surfaces of internal bore holes, the entrapment of moisture in the bore holes, and the presence of internal stresses created by heat treatment.

The fact that the crack had propagated over a substantial distance by SCC without causing static or fatigue failure of the fork suggested that service induced stresses were not unduly high, and therefore the problem could be solved by resorting to the T73 temper. At the same time the corrosion protection system was improved by shot peening all surfaces, and by applying a chemical conversion coating (Alodine 1200) followed by a single coat of wash primer and two coats of epoxy paint.

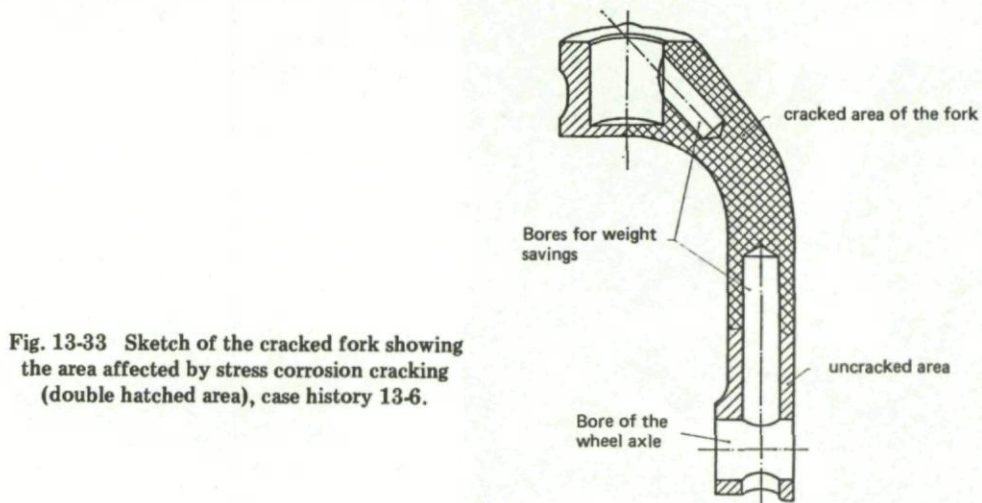
Fig. 13-33 Sketch of the cracked fork showing the area affected by stress corrosion cracking (double hatched area), case history 13-6.

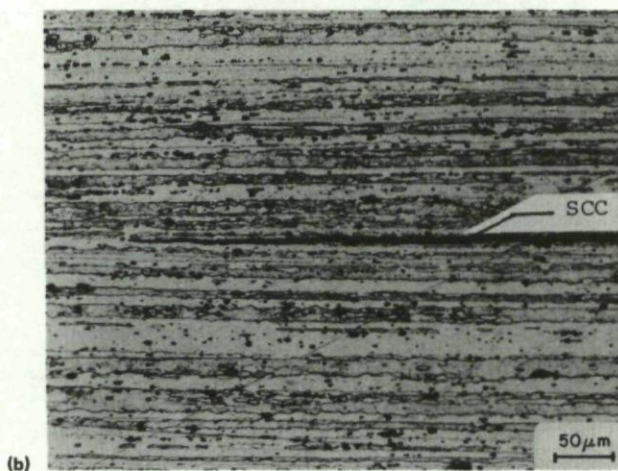
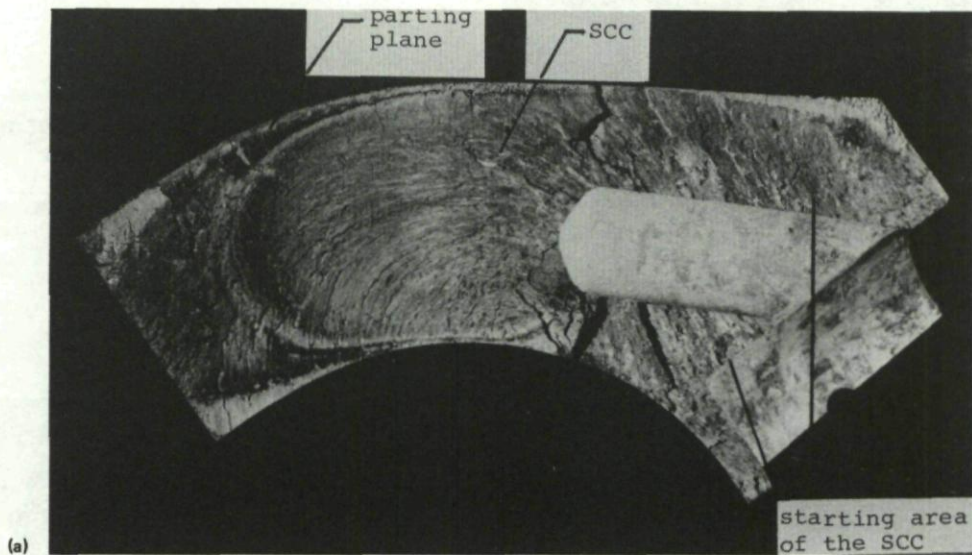
Fig. 13-34 Stress corrosion cracking in a 7075-T6 NLG fork, case history 13-6.

- (a) Macroscopic view of the SC crack in the fork.
- (b) Section through the tip of the crack showing the intergranular crack path.
